**Flood Control Project Maintenance
Levee Inspections**

Maintenance Issue Types Only, Levee Inspection Report By Mile - Spring 2020

Reclamation District No. 1500 Sutter Basin

Waterway	Bank	Unit Miles	Inspection Start/End	Inspector
Unit No. 01 Sacramento River	Left	33.15	03/17/2020 03/18/2020	Zach Jojola

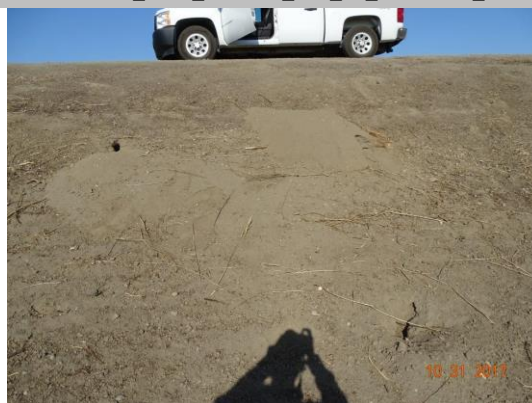
Photo 2 of 2 : SP_2020_RD1500_189_99_20200228_00040.jpg

View of holes and mounds on landside slope. Fall 2017.

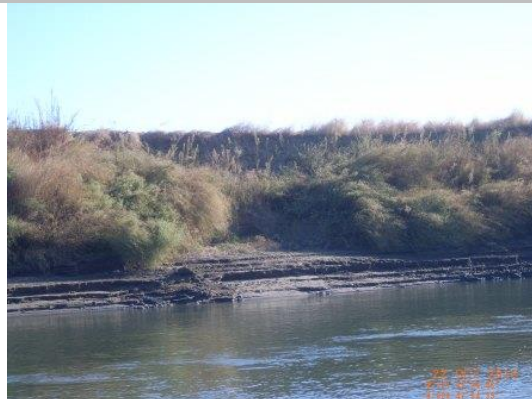
Photo 1 of 1 : SP_2020_RD1500_189_87_20200228_00034.jpg

2017 Site ID: SAC 87.1 L
Status: Eroding
2017 Field Notes: Large whole bank failure section in middle of site.
Site History: 2010 - The upstream end of the repair site at 87.0. Repair did not extend far enough upstream. 2011 - New erosion pockets. 2012 - Minor new erosion at toe. 2013 - Minor new erosion. 2015 - Significant new toe erosion. 2016 - Fresh erosion on riverbank.

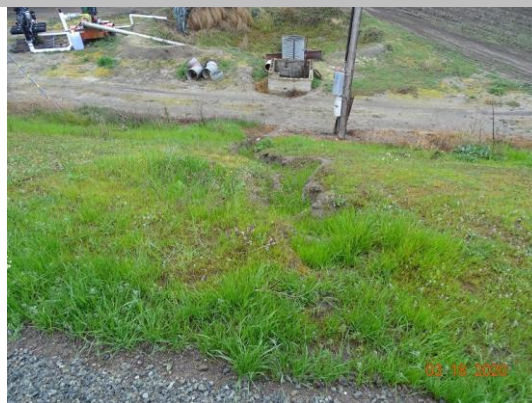
Photo 1 of 1 : SP_2020_RD1500_189_139_20200319_00204.jpg

LM Start	5.19	Rating **	M	Issue No.	139
LM End	5.19	Issue Type +	Ma	Location *	LS
Category	Earthen Levee			GPS Latitude/Longitude	
				Start	End
Item	Erosion / Bank Caving			38.802344 °	38.802344 °
				-121.712940 °	-121.712940 °
DWR ID	DWR_RD1500_01_s_2020_139				
Comment Code					
E2 : Schedule repair of erosion site prior to the next inspection.					
Inspector Comment					
Runoff erosion on the landside slope.

View of the erosion on the landside slope. Spring 2020.

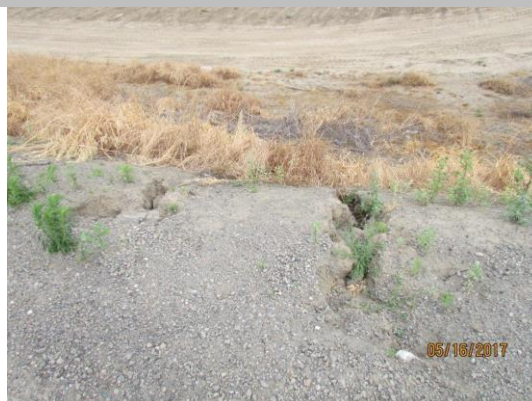
Photo 1 of 1 : SP_2020_RD1500_189_116_20200228_00046.jpg

LM Start	12.01	Rating **	M	Issue No.	116	
LM End	12.01	Issue Type +	Ma	Location *	LS	
Category	Earthen Levee			GPS Latitude/Longitude		
				Start		End
Item	Erosion / Bank Caving			38.870730 °		38.870730 °
				-121.752908 °		-121.752908 °
DWR ID	DWR_RD1500_01_s_2017_116					
Comment Code						
E2 : Schedule repair of erosion site prior to the next inspection.						
Inspector Comment						
There is runoff erosion on the landside levee slope.

View of erosion on landside slope. Spring 2017.

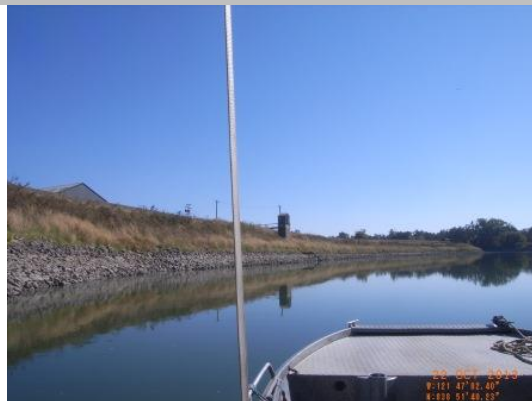
Photo 1 of 1 : SP_2020_RD1500_189_89_20200228_00035.jpg

LM Start	13.98	Rating **	A/W	Issue No.	89
LM End	14.28	Issue Type +	Ma	Location *	WS
Category	Supplemental			GPS Latitude/Longitude	
				Start	End
Item	2017 USACE Erosion Survey			38.857239 °	38.861899 °
				-121.783771 °	-121.784057 °
DWR ID	DWR_RD1500_01_f_2018_89				
Comment Code					
Inspector Comment					
2017 Site ID: SAC 99.0 L					
Status: Eroding					
2017 Field Notes: Rock continues to unravel.					
Site History: 1997 - Intermittent toe failure of the hand placed riprap; failure of toe materials.

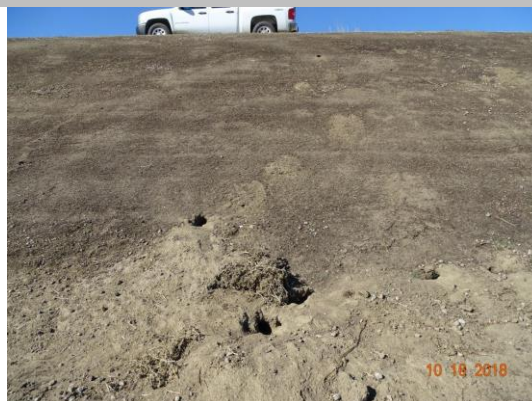
Photo 1 of 1 : SP_2020_RD1500_189_92_20200228_00036.jpg

View of rodent holes on the landside slope. Fall 2018.

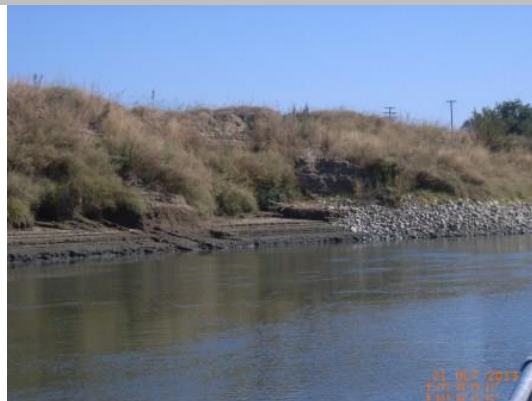
Photo 1 of 1 : SP_2020_RD1500_189_83_20200228_00032.jpg

Comment Code					
Inspector Comment					
2017 Site ID: SAC 116.5 L					
Status: Eroding					
2017 Field Notes: pipe and pump encroachment. site has been stable for a few years.					
Site History: 2003 - New sedimentation and some new small toe scallops at the upstream end; downstream end has some new erosion.					
2004 - Some new erosion at the toe and upper bank and some small new rotational failures (mainly minor, except at the downstream end).					
2007 - Some new slumps. 2009 - Some new scallops and site was extended upstream. 2010 - New deposition along upstream end of site, however there is also new erosion throughout the site. Site seems to be worsening, and eroding fast. Large habitat for bank swallows. 2011 - Some new minor erosion. 2012 - Minor new erosion. 2016 - Fresh erosion on lower bank.

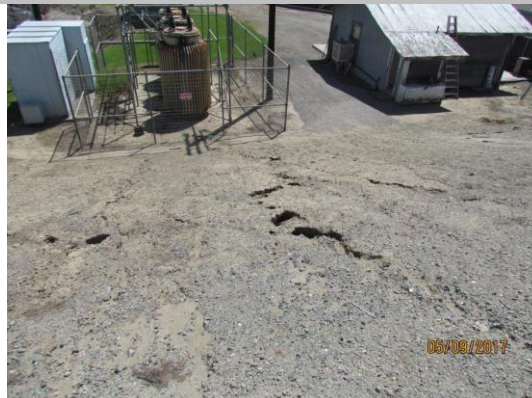
Photo 1 of 1 : SP_2020_RD1500_189_144_20200228_00057.jpg

View of erosion on landside slope. Spring 2017.

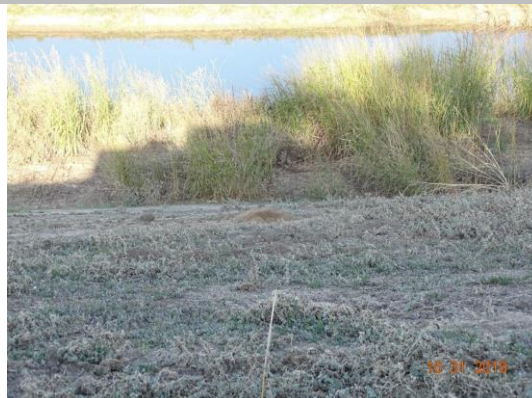
Photo 1 of 1 : SP_2020_RD1500_190_20_20200228_00010.jpg

View of rodent hole on the landside slope. Fall 2019.

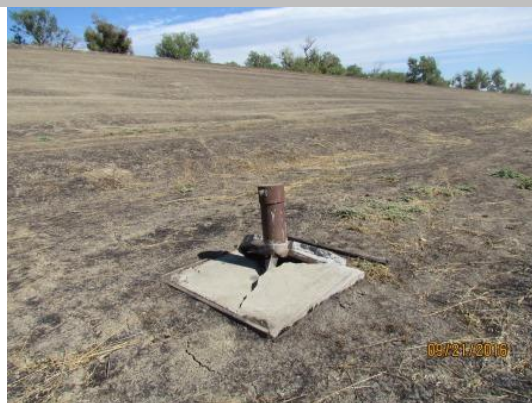
Photo 1 of 3 : SP_2020_RD1500_190_4_20200228_00001.jpg

View of underseepage relief well with destroyed concrete pad as well as PVC pipes. Fall 2016.

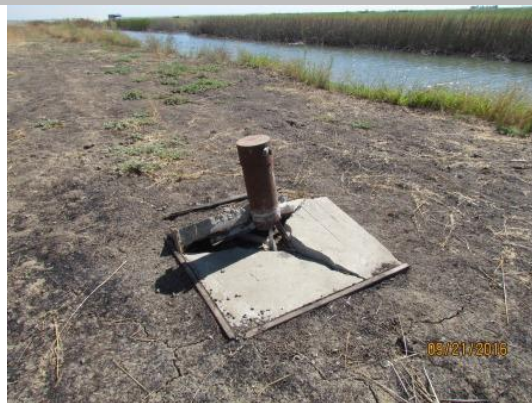
Photo 2 of 3 : SP_2020_RD1500_190_4_20200228_00002.jpg

Another view of damaged well. Fall 2016.
